Can Protracted Drought Undermine the Structural Integrity of California's Earthen Levees?

Farshid Vahedifard, M.ASCE

Forum papers are thought-provoking opinion pieces or essays founded in fact, sometimes containing speculation, on a civil engineering topic of general interest and relevance to the readership of the journal. The views expressed in this Forum article do not necessarily reflect the views of ASCE or the Editorial Board of the journal.

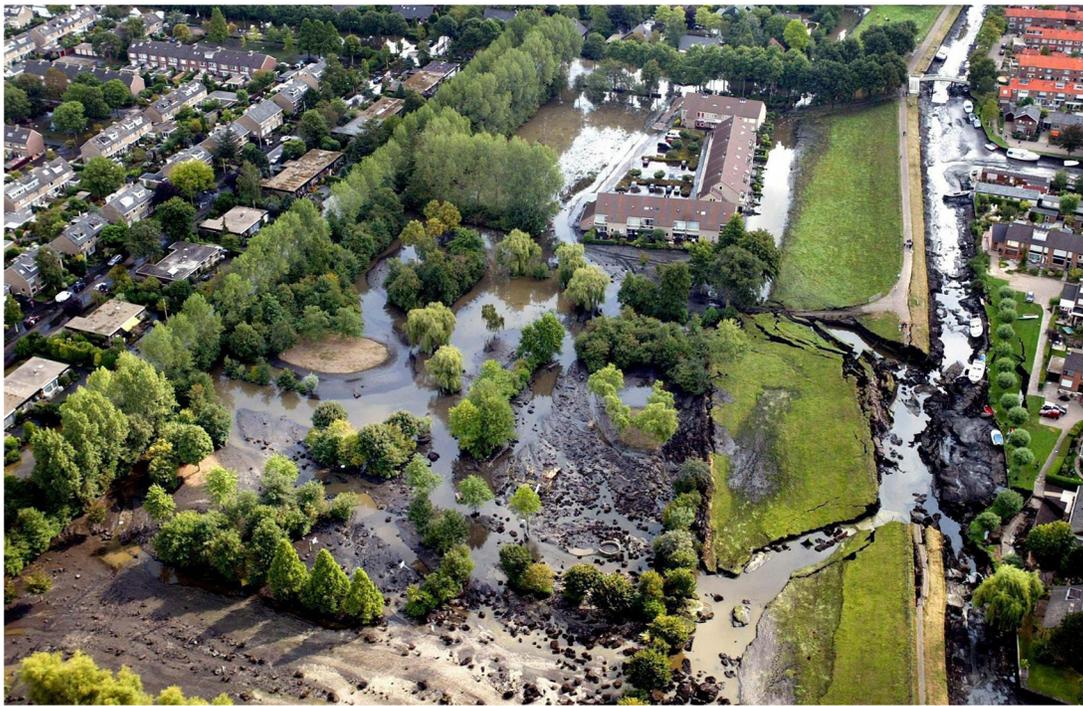
Fig. 3. Aerial view of the failure of the Wilnis levee in the Netherlands, early Tuesday, August 26, 2003, following overnight flooding superseded a drought season; a 100-m-long section of the levee collapsed, causing the evacuation of around 2,000 inhabitants (courtesy of Koen Suyk, EPA/Newscom)

Another example of the impacts of extreme drought on earthen structures is the failure of the Wilnis Dike in the Netherlands (Van Baars 2005). The Wilnis Dike serves as a secondary dike, and the surficial soil layers in the vicinity of the Wilnis Dike failure consisted mostly of a highly anisotropic deposit of peat overlying a thick layer of dense sand. During one of the driest summers in more than 50 years, the Wilnis Dike failed in August 2003. Field inspections revealed small and large desiccation cracks in the peat material. Fig. 3 shows the largest failure occurring in the Wilnis Dike. The failure consisted of a 10-m horizontal translation that was triggered by the drought-induced cracks and other factors, namely, reduction in soil unit weight and shrinkage (Van Baars 2005). The horizontal translation of the dike led to rapid dissipation of water in the Wilnis Canal, displacing approximately 2,000 residents in the Wilnis Village from their homes and placing roughly 600 houses under about half a meter of water (Van Baars 2004). Reduction in self-weight, shrinkage, and desiccation cracking of the peat material were identified to be the principal contributing factors to the failures of the Wilnis Dike during the unusually dry season in 2003 (Van Baars 2005).
